**Flood Control Project Maintenance  
Levee Inspections**

**Fall 2012 Levee Maintenance Deficiency Summary Report**

**Flood Control Project Maintenance  
Levee Inspections  
LMA District Cover Sheet  
Fall 2012 Levee Inspection Results**

**Reclamation District No. 0003 Grand Island**

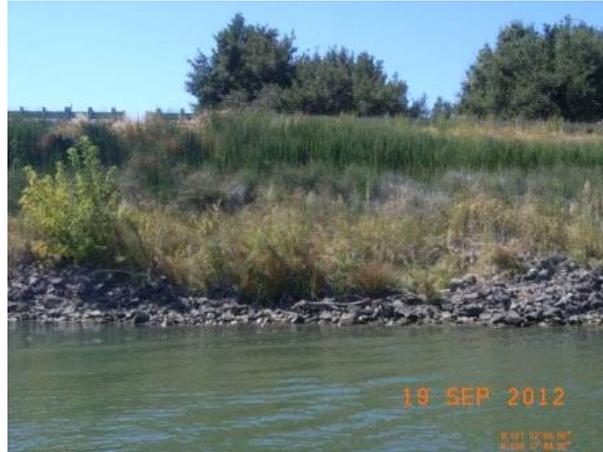
USACE 2012 Photo #1
USACE2012_SAC_31-6_R_1.jpg

Levee Mile Report Line	80
Start Levee Mile	16.54
End Levee Mile	16.54
Location	Water Side
Category	Supplemental
Item	USACE Erosion Survey

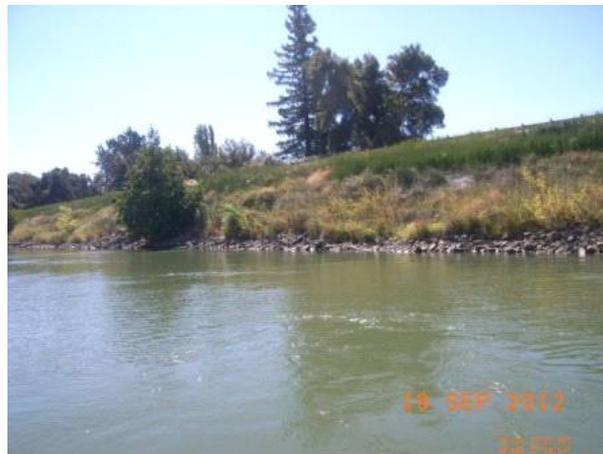
USACE 2012 Photo #2
USACE2012_SAC_31-6_R_2.jpg

Levee Mile Report Line	80
Start Levee Mile	16.54
End Levee Mile	16.54
Location	Water Side
Category	Supplemental
Item	USACE Erosion Survey

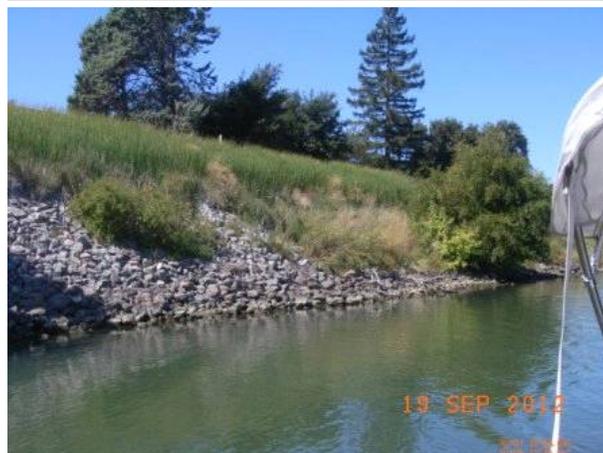
USACE 2012 Photo #3
USACE2012_SAC_31-6_R_3.jpg

Levee Mile Report Line	80
Start Levee Mile	16.54
End Levee Mile	16.54
Location	Water Side
Category	Supplemental
Item	USACE Erosion Survey

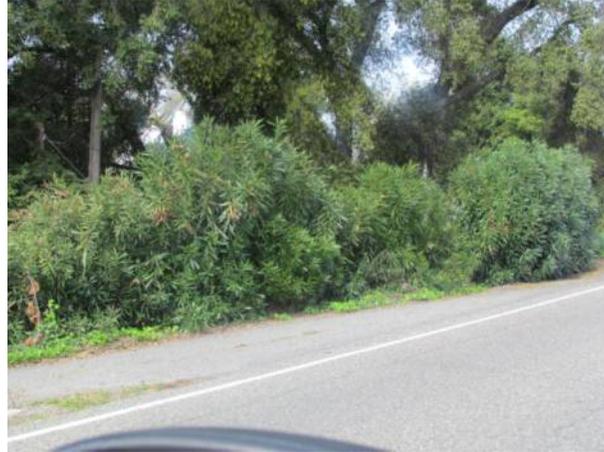
Levee Mile Report Line	81
Start Levee Mile	16.84
End Levee Mile	16.90
Location	Land Side
Category	Earthen Levee
Item	Vegetation
Looking west at landscaping on landside shoulder and slope.	
richard_f_20121012_413.jpg
